## Inspection Report

### Vamdrup Fjernvarme

Reported by:	Glenn Andersson
Date reported:	2022-02-16
Inspection performed by:	Glenn Andersson
Place of visit:	Nygade 6, Vamdrup.
Country of visit:	Denmark

Work order no:	WO-791
Date started:	2022-02-15
Date finished:	2022-02-15
Customer ref no:	N/A
Engine type:	Wärtsilä 16V25SG
Generator no:	#1
Engine no:	4099
Engine speed:	1000 Rpm.
Rated power:	3240 kW.
Fuel type:	Gas
Running hours:	54 430 Hrs.

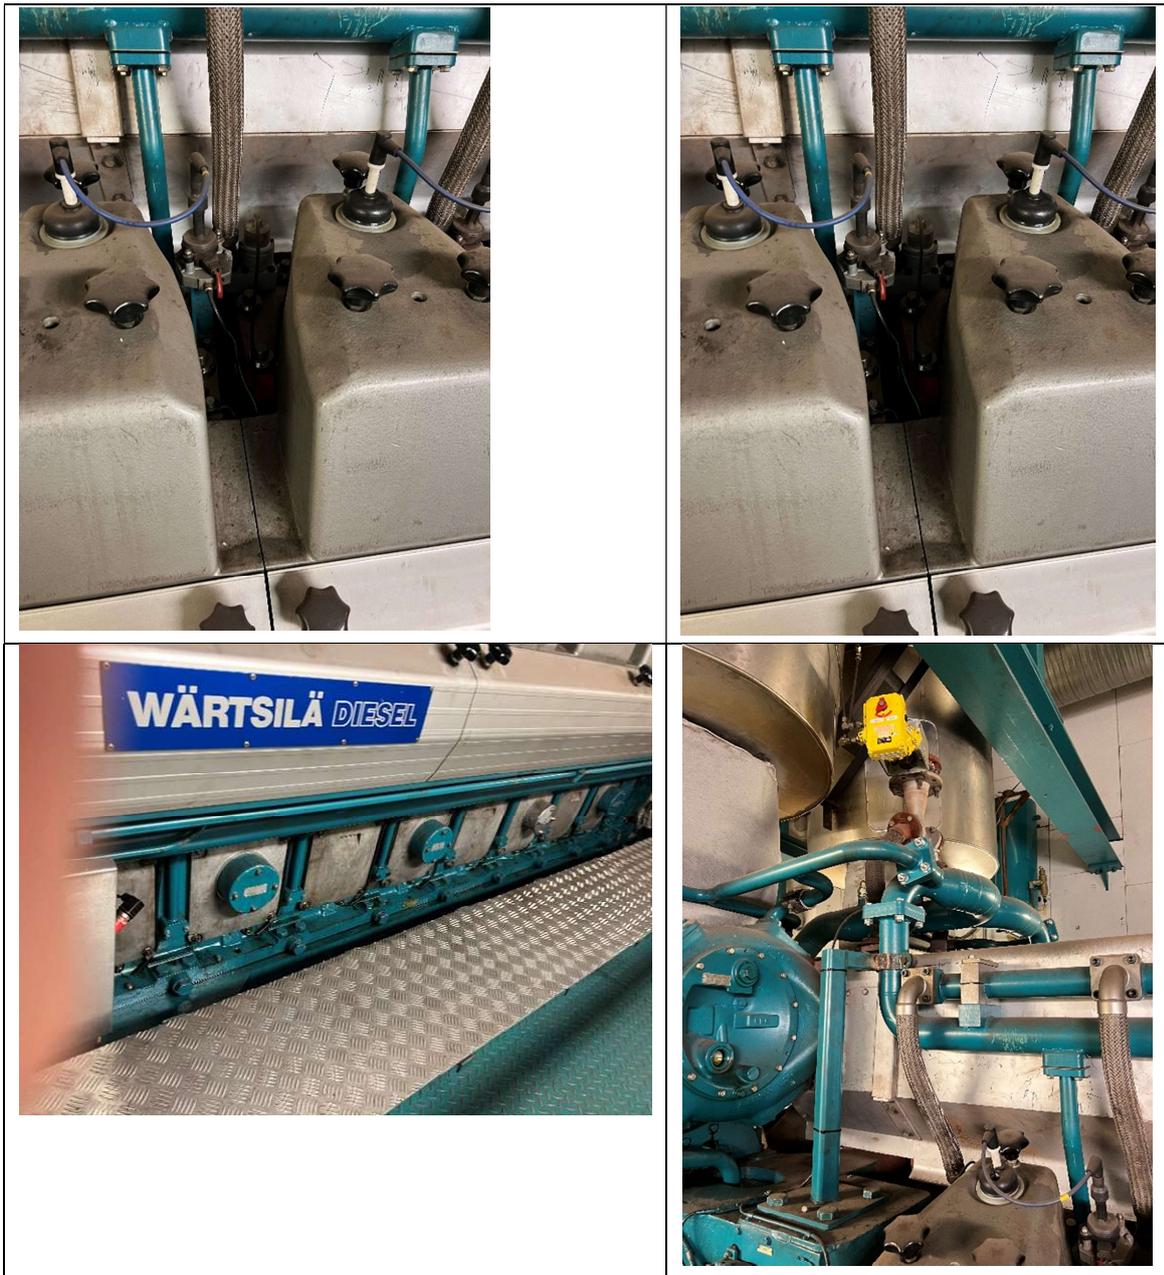
## 2.1 Overall condition

Engine has been in operation for approx. 55 000 hrs and condition for what you can see by a visual inspection is in general very good, when looking on overall condition and reports it seems to be well maintained. It was not possible to make a test run as engine was disconnected.  
Engine was overhauled at 50 000 hrs, acc. to report from Wärtsilä DK.

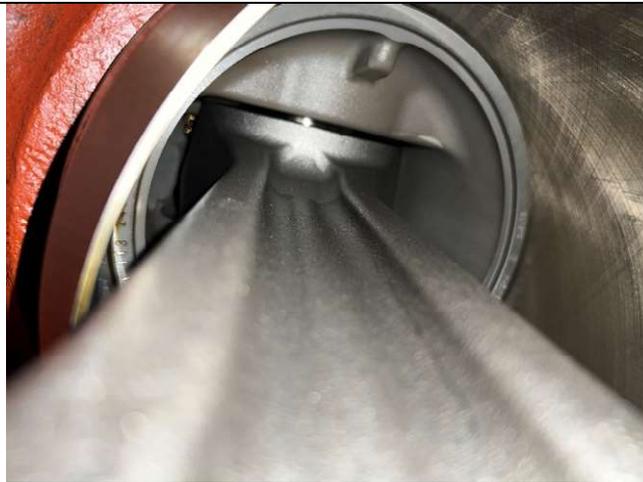
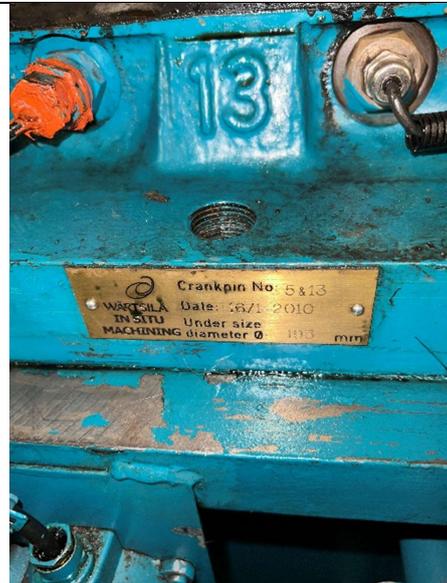
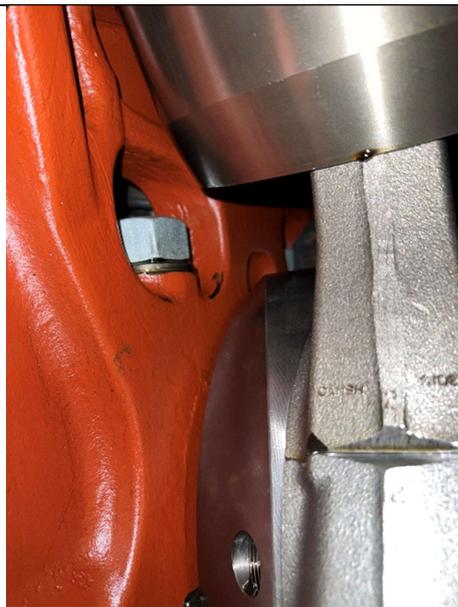
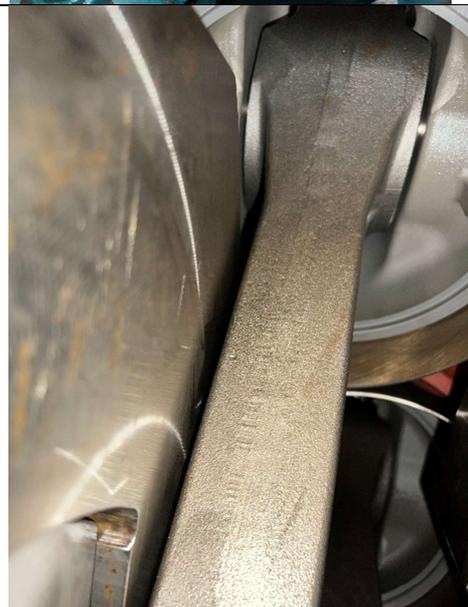
## 2.2 Engine block and crankcase

Engine block and crankcase were visually inspected without disassembly. All visible surfaces are in good condition and no water leakages in crankcase or around cylinders were noted.

Crankcase was very clean and honing pattern inside cylinder liners looked intact for as far as visible. Acc. to report from 50 000 Hrs. service engine block has been machined on landing surfaces for cylinder liners, distance has been compensated with shim rings underneath cylinder liner. (This is a very common repair method on Wärtsilä Nohab engines.). 5 pcs cylinder liners were replaced at 50 000 Hrs. service due to cracks.

Crankpin for cylinders 5 and 13 has been grinded 2,00 mm 26/1-2010 for unknown reason.

Missing documentation for this repair. However this hasn't caused any degrading of output on engine and oversized bearings are available.

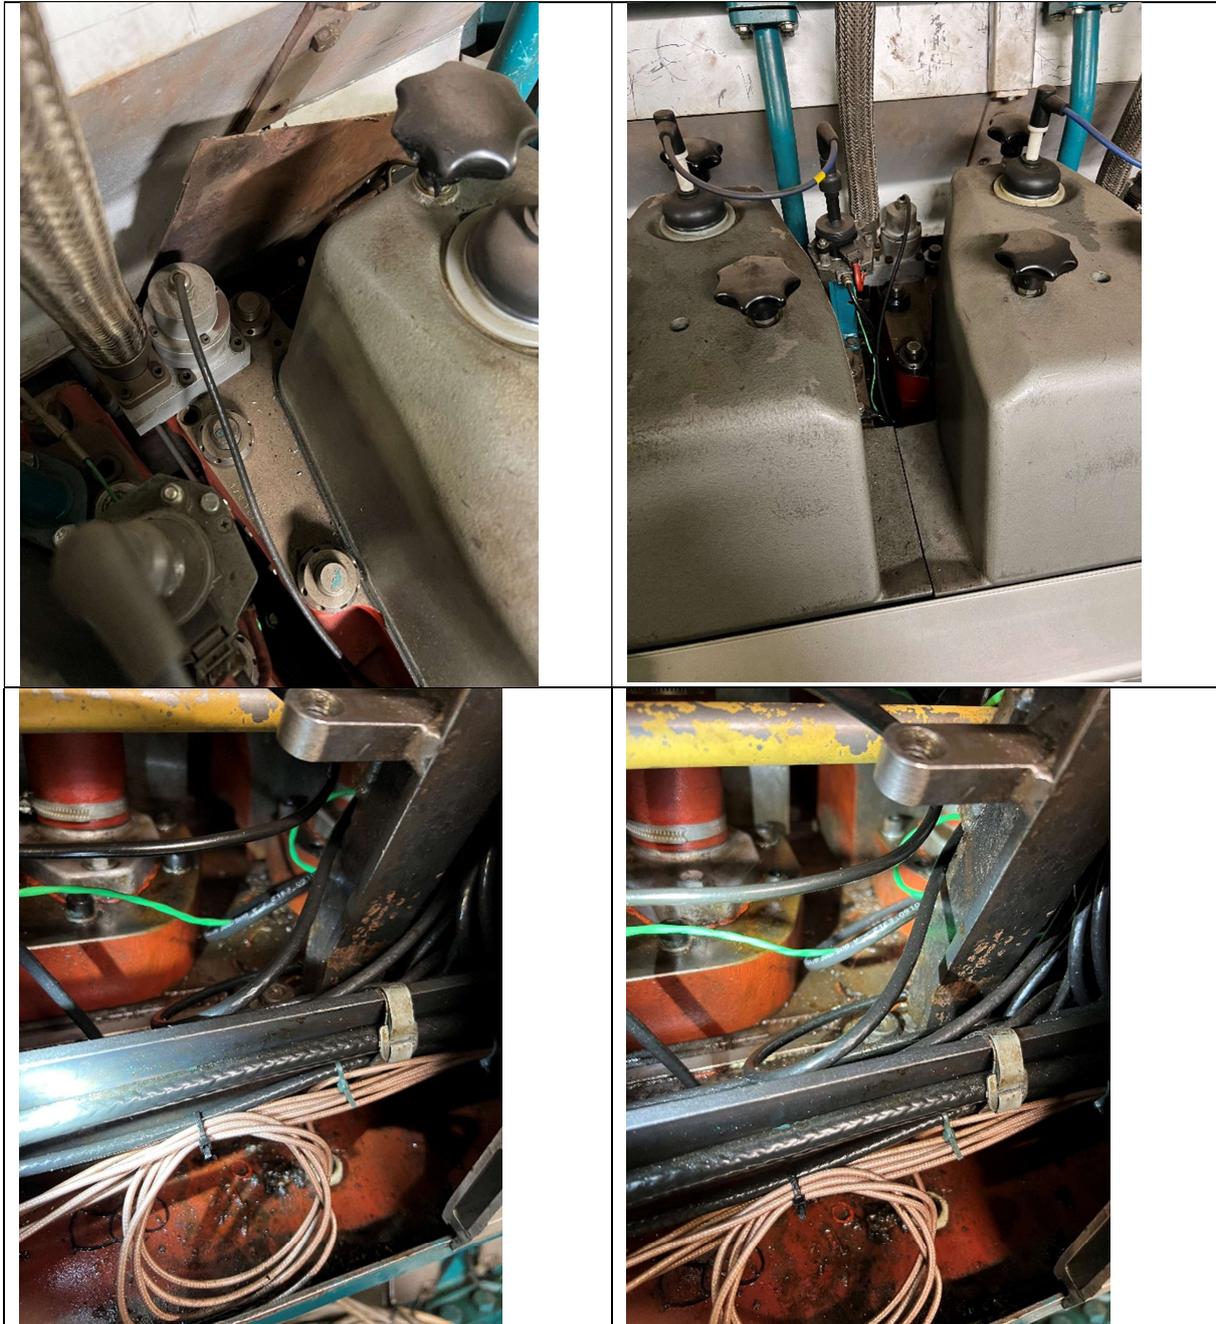
## 2.3. Cylinder heads

All visible surfaces on cylinder heads are in good condition, minor indications of water leaks from connections on some cylinder heads, this might be due to cold condition.

Cylinder heads were overhauled at 50 000 Hrs service acc. to report. Internal parts in cylinder heads were in ok condition acc. to measurement reports and reinstalled.

2x cylinder heads were renewed due to cracks at time of service, remaining cylinder heads were found in good condition.

**3.1 Seal minor leakages were found next to cylinder heads, due to the collar on cylinder heads it is difficult to locate. Such leakages usually stops when engine is heated.**

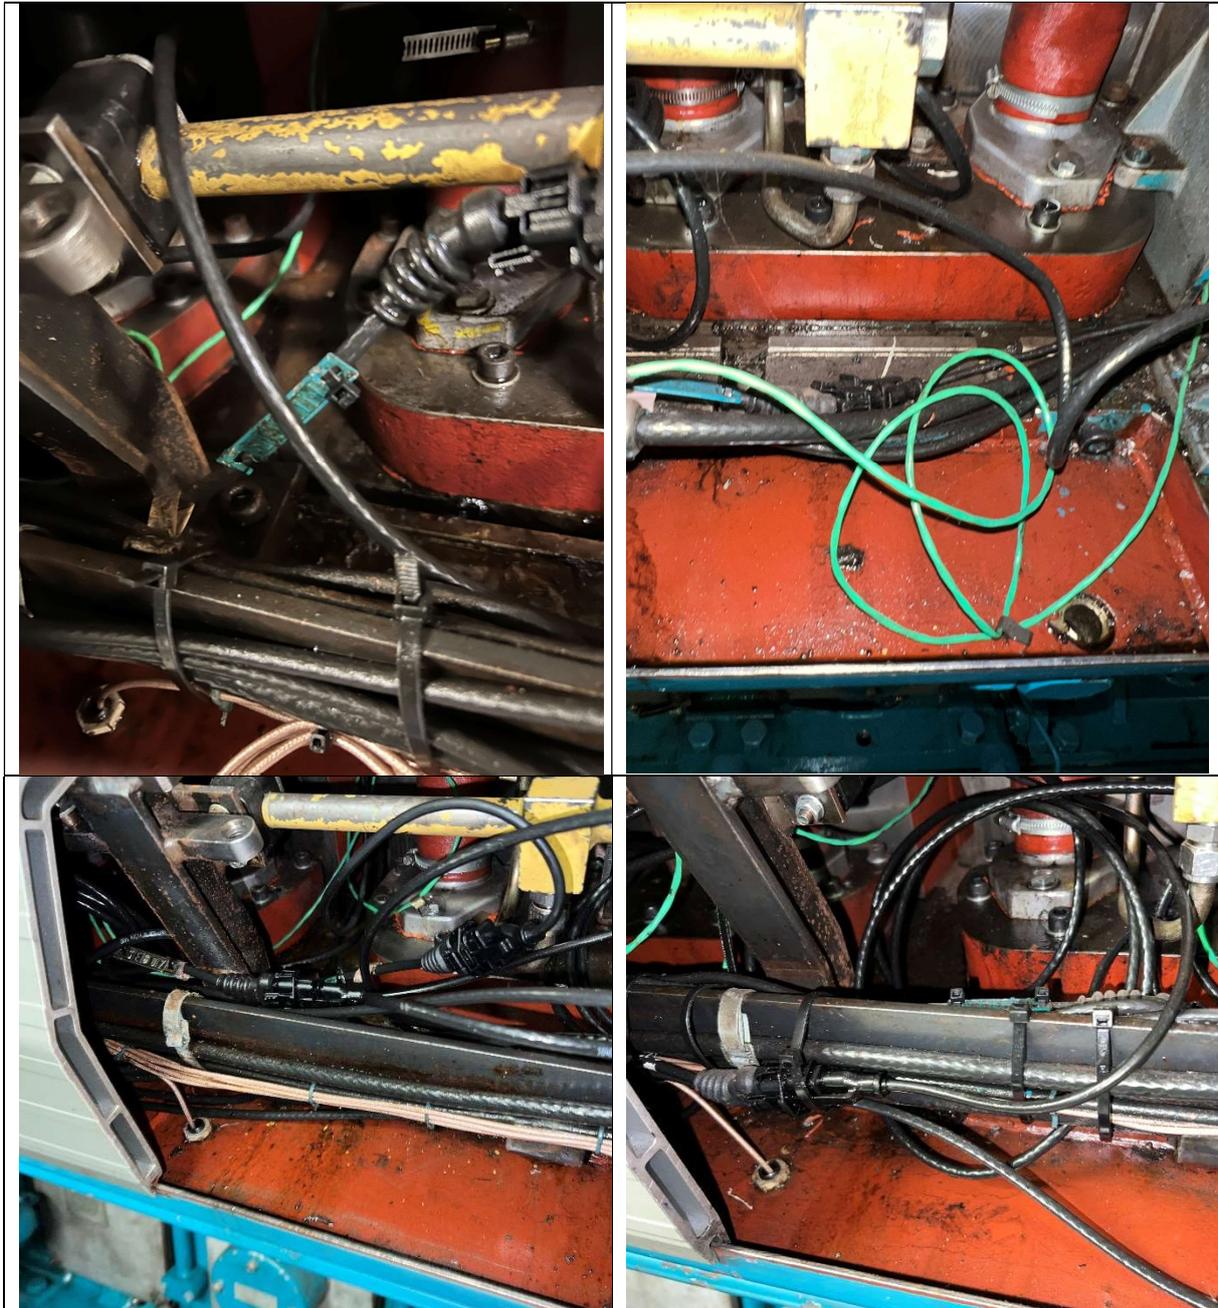
## 2.4 Hotbox

Hot box on both A and B- bank were inspected. Condition of pipings and visable parts was found in ok condition. Minor oil leakages located on and next to valve lifter brackets.

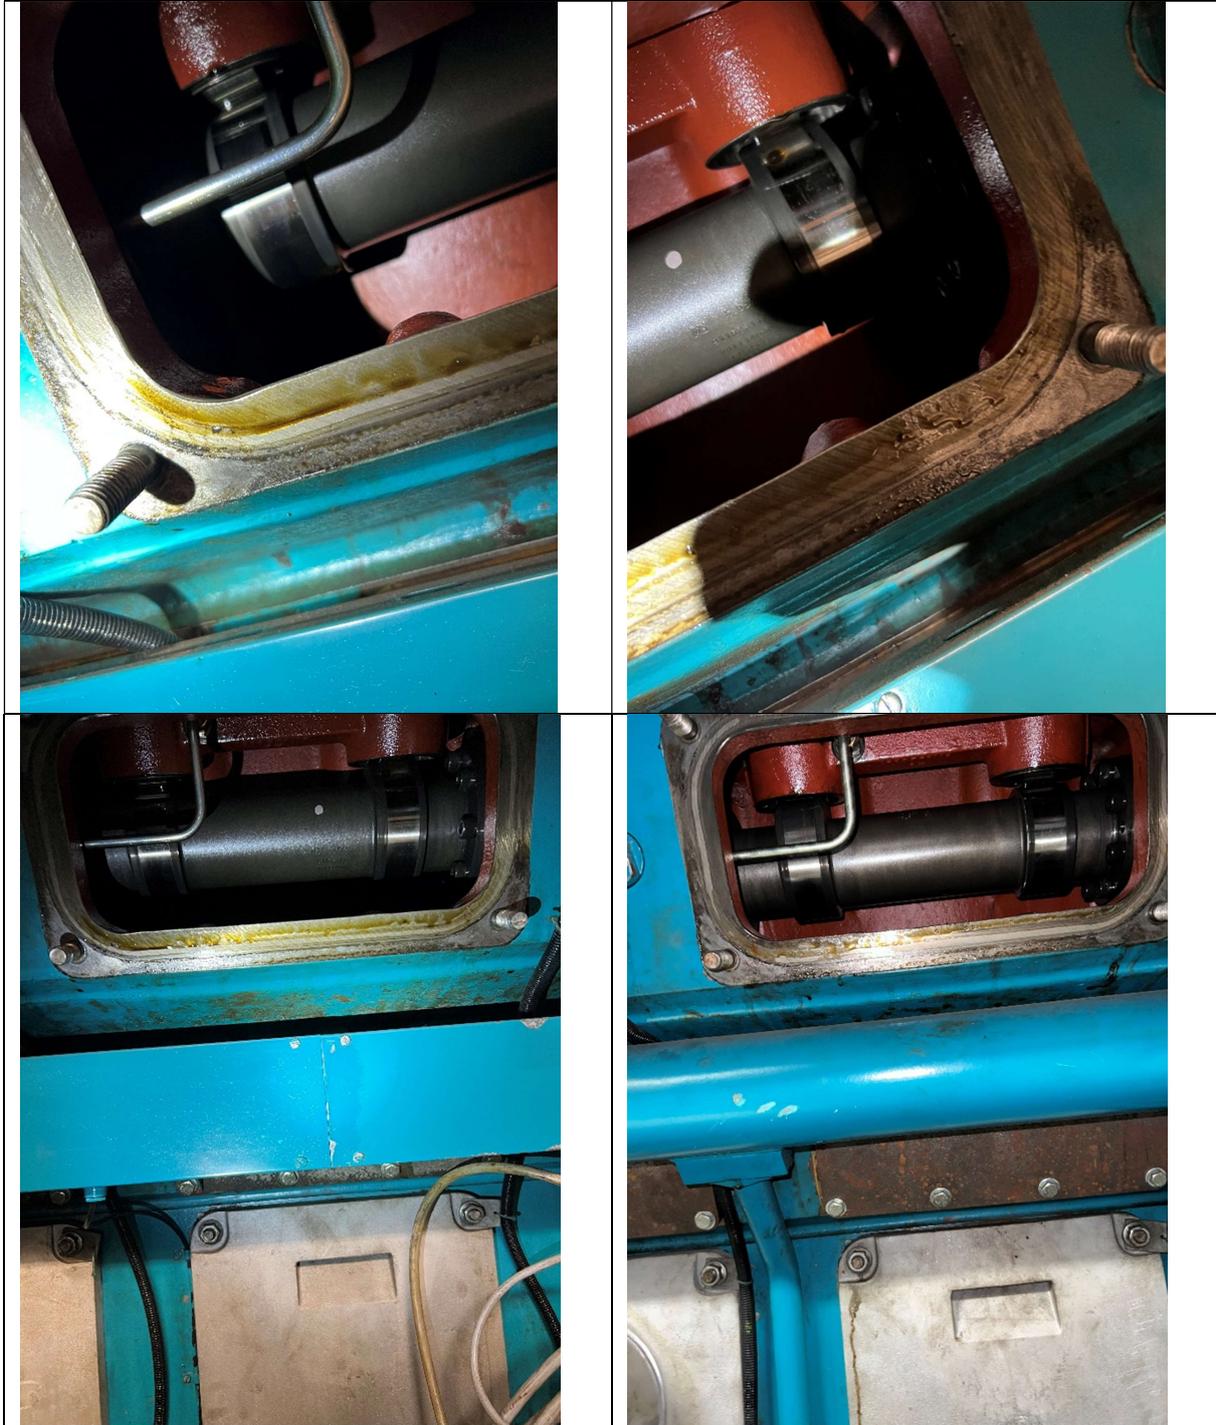
## 2.5 Camshafts

Camshaft sections were inspected and found in good condition.

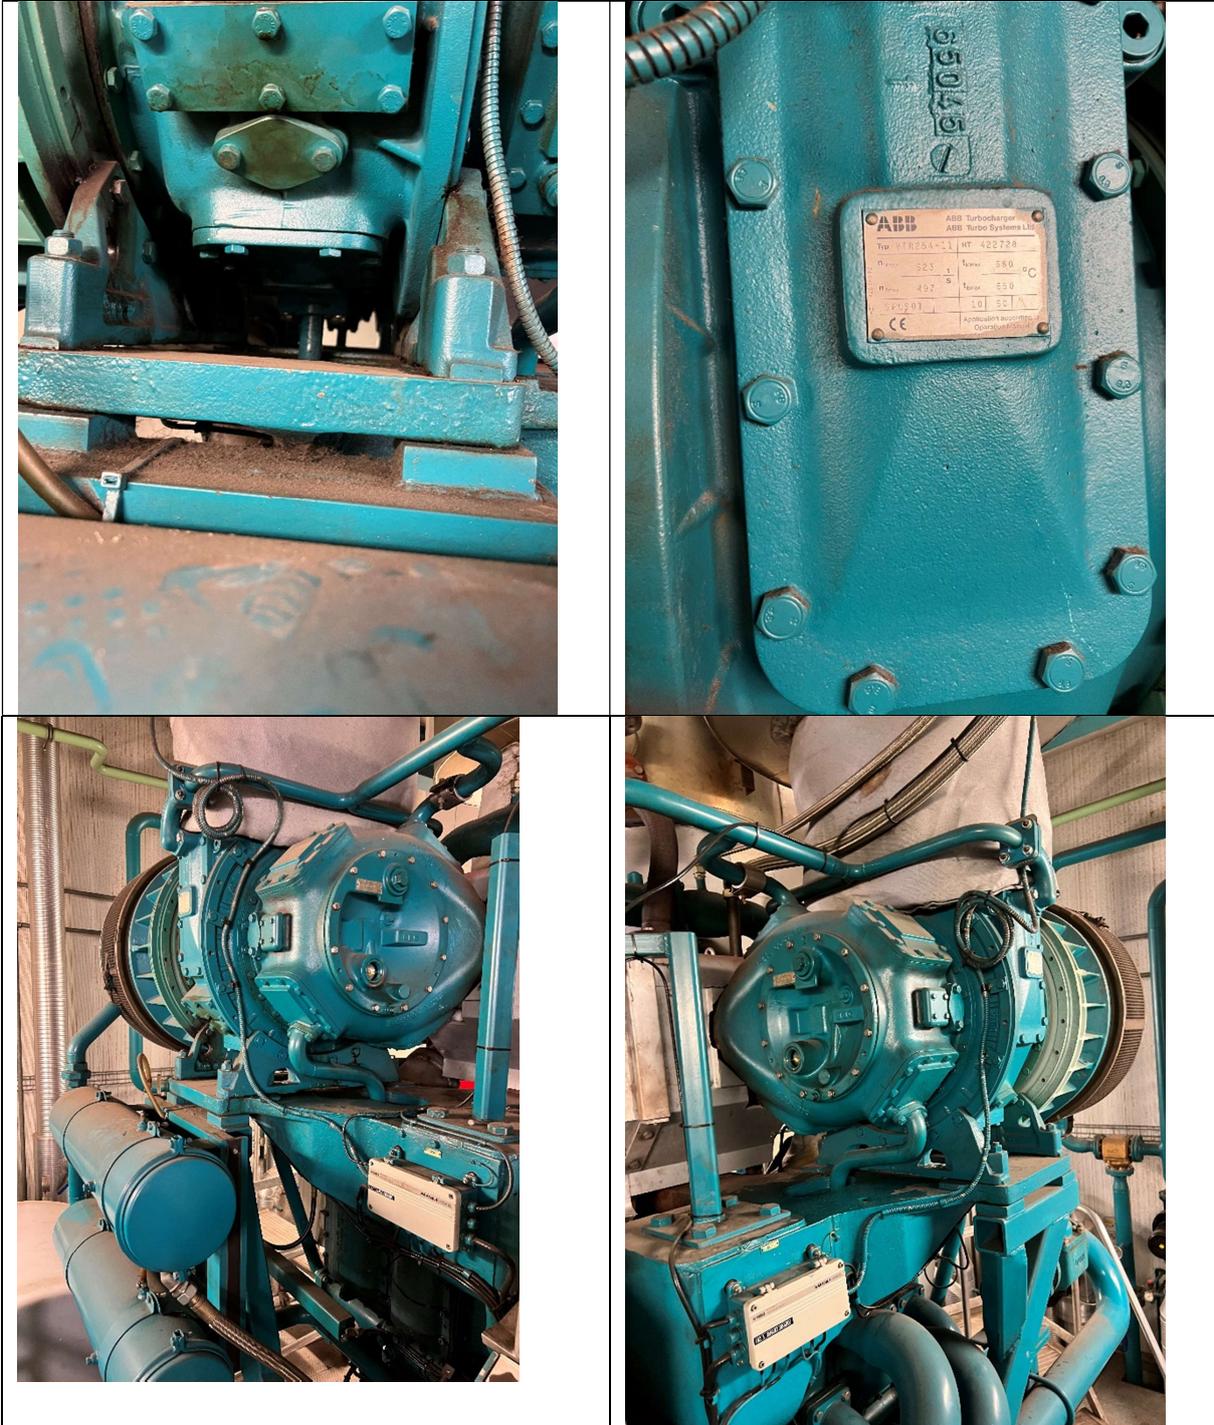
## 2.6 Turbochargers

Turbochargers were visually inspected from outside and was found intact without damages. Acc. to report from 50 000 service both turbochargers were cleaned, inspected and bearings renewed.

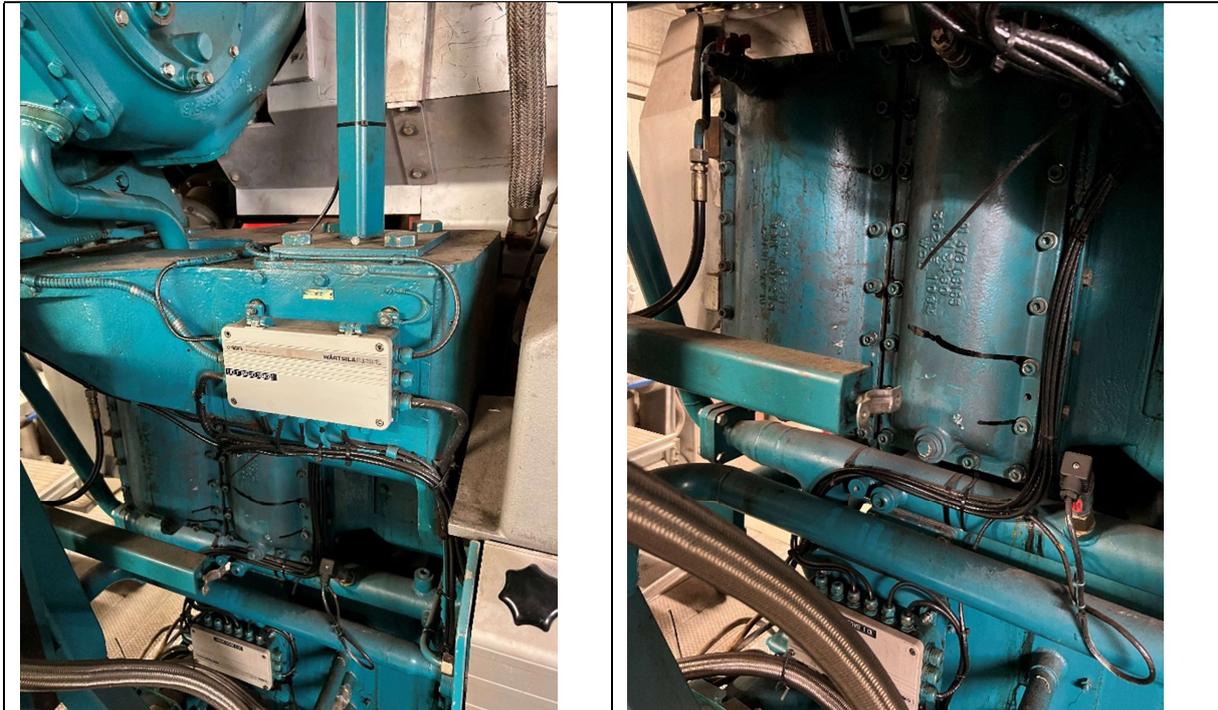
## 2.7 Fore end with engine driven pumps and filters etc.

Lubricating oil pumps – No leakages or discrepancies were noted.

Freshwater pump - No leakages or discrepancies were noted.

Thermostatic valve housing – Good visible condition.

Charge air cooler – Visible outer surfaces was in good condition.

Lube oil filter unit – Good condition.

Pipe connections, fore end – Some leakages in connections noted. Recommend renewing seals.

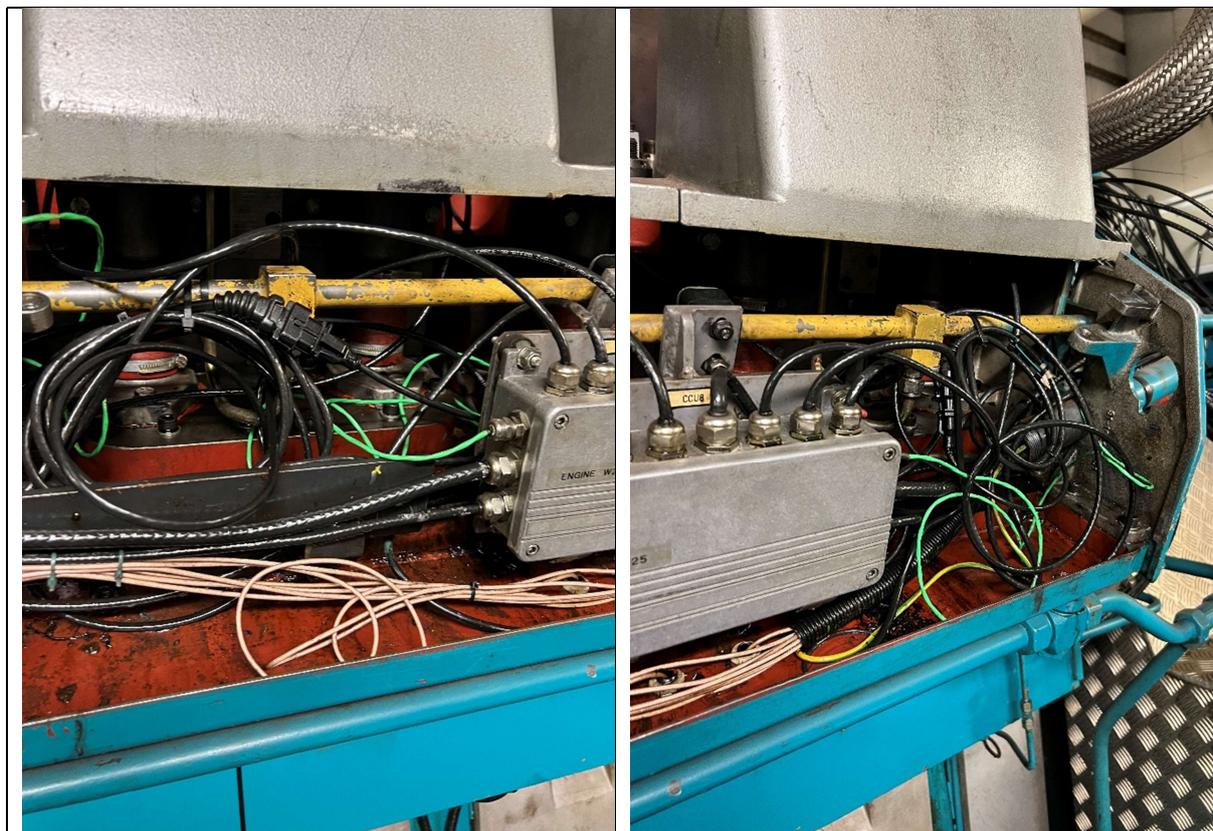
## 2.8 Electrical equipment

Electrical equipment was visually intact and was working properly when engine was stopped according to staff on site. Wiring from CCU boxes are a bit messy and could be drawn in a better way
